2013 Tchefuncte River Complex Aquatic Vegetation Control Plan

LDWF, Inland Fisheries

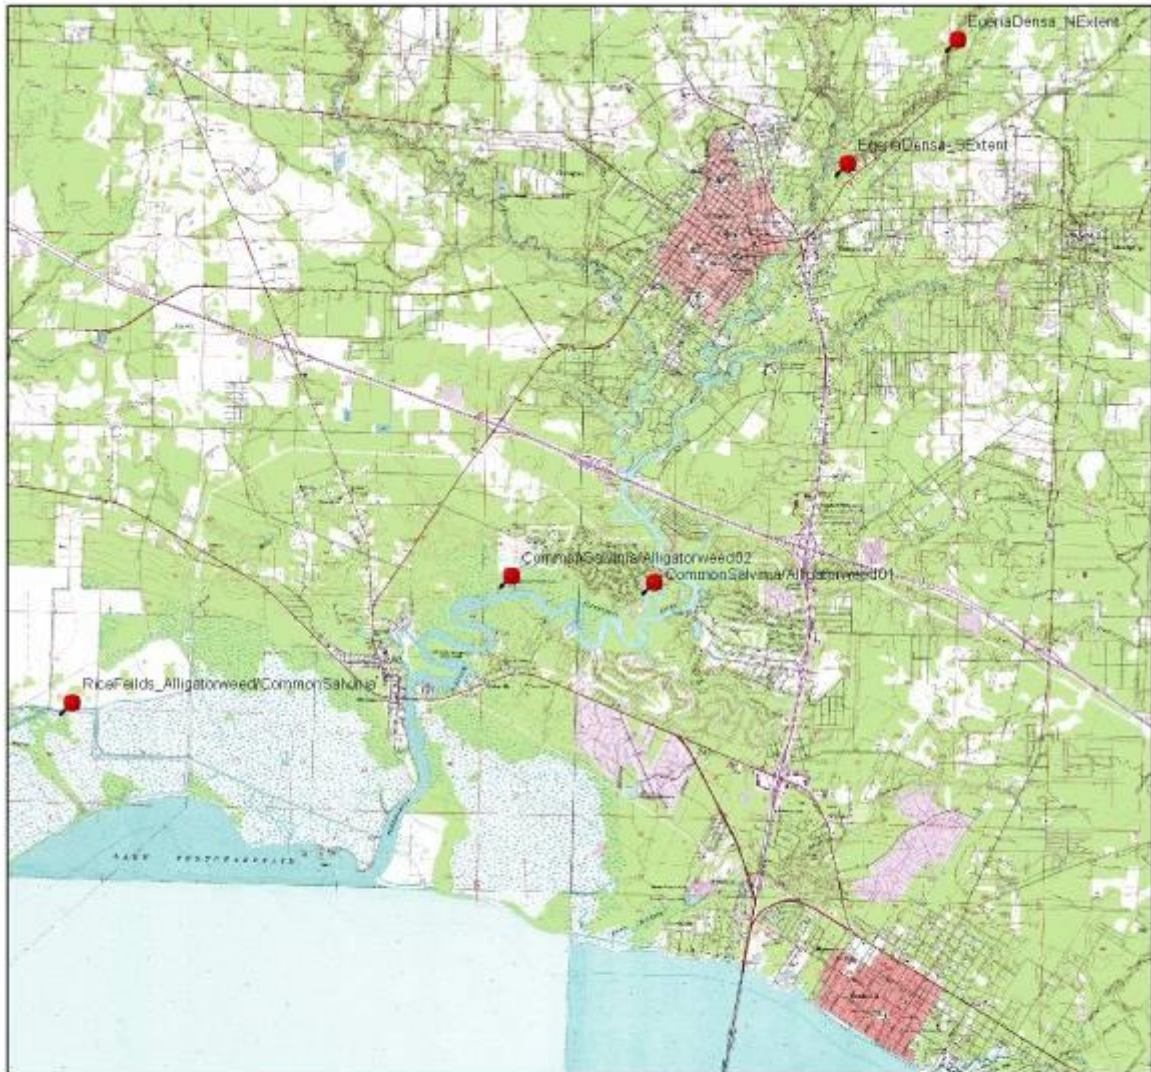
Map 1. Map of Tchefuncte River complex with labeled aquatic plant issues and locations.
